# Mechanical Potato Harvesting

studies conducted in Kern County indicated less injury to potatoes when harvested by machine than by hand harvesting

# Area-wide Drainage

herringbone pattern and interception  
type systems solve drainage problems

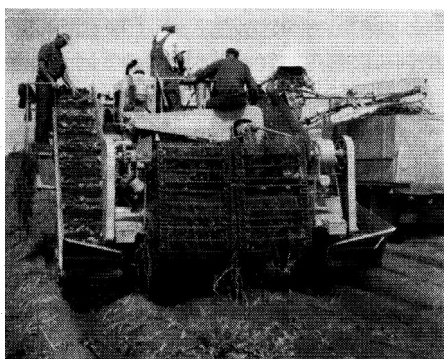
Rear view of harvester showing weed and vine eliminator chains in center, and conveyors on the sides elevating the potatoes to the front cross conveyor.

scavengers alternated in following the harvester and picking up potatoes—carried over the rear on the vine and weed eliminator chain—and placing them on undug rows. No determination was made of the amount of potatoes carried over by the chain, but it appeared to be most serious with green vines and in weedy spots.

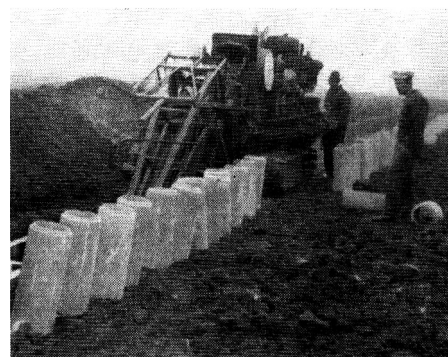
Installing concrete tile drainage system.

Interpretations of water table fluctuations and determinations of hydraulic conductivity of the soil indicated that an area-wide drainage system installed in a herringbone pattern of 40,000' of 4" laterals and 10,000' of 8" main line should lower the water table to sufficient depth to eliminate water damage to trees. The system was installed with concrete tile laid about 8' deep and with a gravity discharge into the San Joaquin River.
