Plastic Shelters for New Lambs

protection from weather during first few days after birth
reduced losses in tests during January–March lambing season

D. T. Torell, C. F. Kelly, T. E. Bond, and W. C. Weir

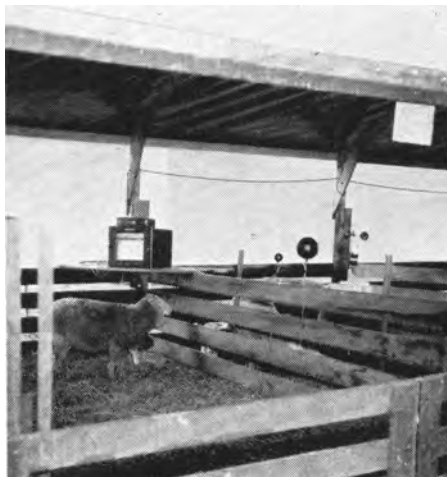
Inside view of shelter showing instruments and protected ewes and lambs.

Shielded thermocouples for measuring air temperatures and globe thermometers for measuring spherical radiation were installed 36" above floor level at the center of each half of the shelter and outside at some distance from the shelter. The responses from these instruments were recorded automatically. In addition, surface temperatures of the plastic films were obtained manually at intervals.

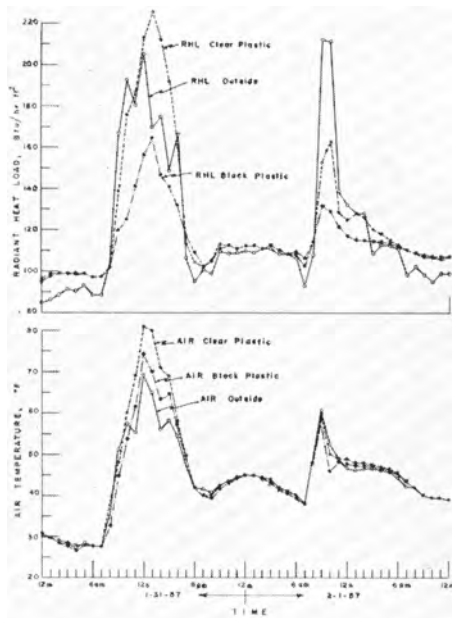
Top—Radiant heat load under translucent plastic, black plastic, and outside the shelter. Bottom—Air temperatures.

Air temperatures, as measured by the thermocouples, showed very little difference at the three locations—outside, under translucent plastic, and under black plastic—during the night and at other times when there was no direct sunshine. However, on sunny days, the air temperature under the translucent plastic was as much as 15°F and under the black plastic 6°F higher than the outside temperature.

The radiant heat load, as measured by the globe thermometers, in BTU—British thermal units—incident upon each square foot of surface area of a sphere, was considerably more under the translucent plastic when the sun was shining than outside, and somewhat less under the black plastic than outside. Spherical radiation includes reflection and radiation from the ground and lower hemisphere surfaces.

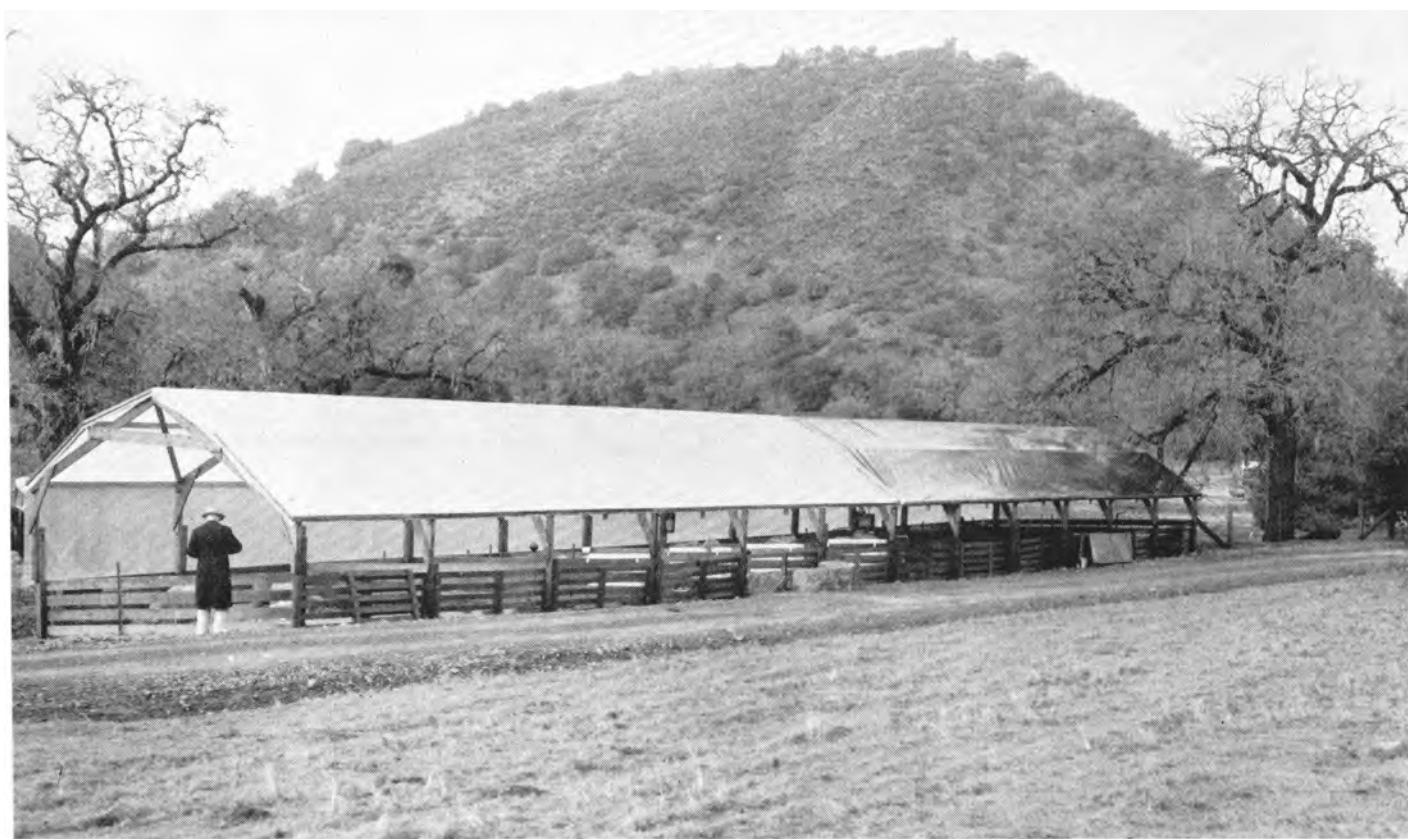
A 20' × 96' plastic-covered shelter. Shielded thermocouples for measuring air temperatures and globe thermometers for measuring spherical radiation were installed under the translucent film, under the black film, and outside the shelter.
