# TILE DRAINAGE

## *Solves Salinity Problems in Tulelake Basin*

K. G. BAGHOTT · C. E. HOUSTON

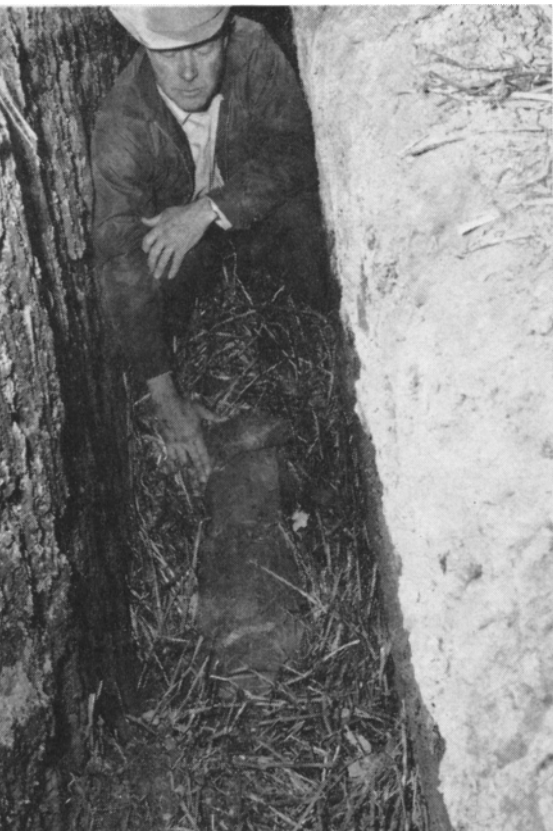
Straw envelope on 6 inch tile drain.

Average costs of 6-inch tile drains installed in the Tulelake Basin have been 70 cents per running foot. Costs increase when it is necessary to use an envelope for the tile. Gravel is not available in the area but cinders or straw are proving a suitable substitute as an envelope material and fiberglass has been used successfully in some locations. However, where a tile line is installed adjacent to an irrigation canal to stop subbing into the field, it has been found best to use either a straw or cinder envelope to increase rate of flow into the tile line.

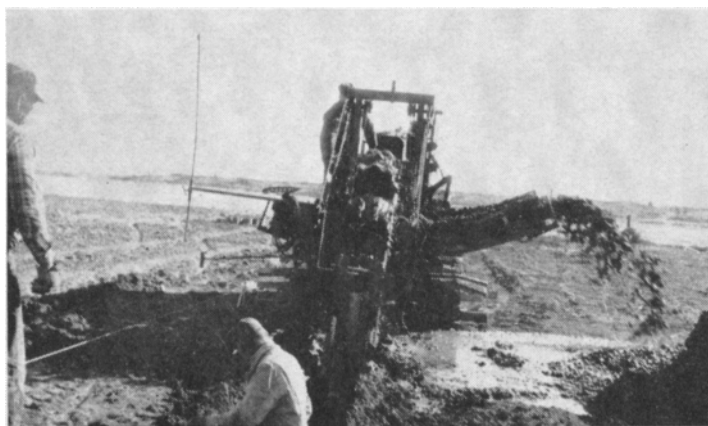
Drain trencher at work in Tulelake Basin.

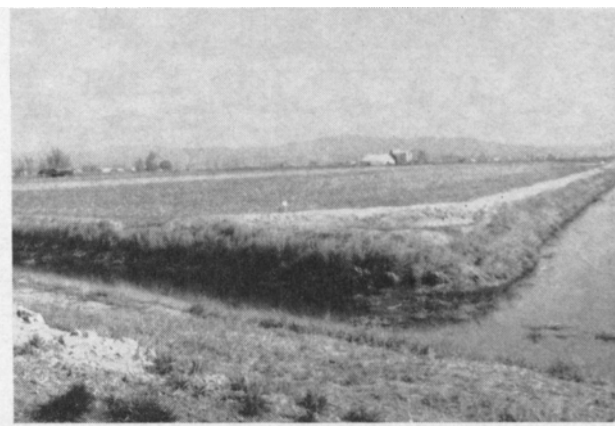
Open drainage system showing height of water in drains.

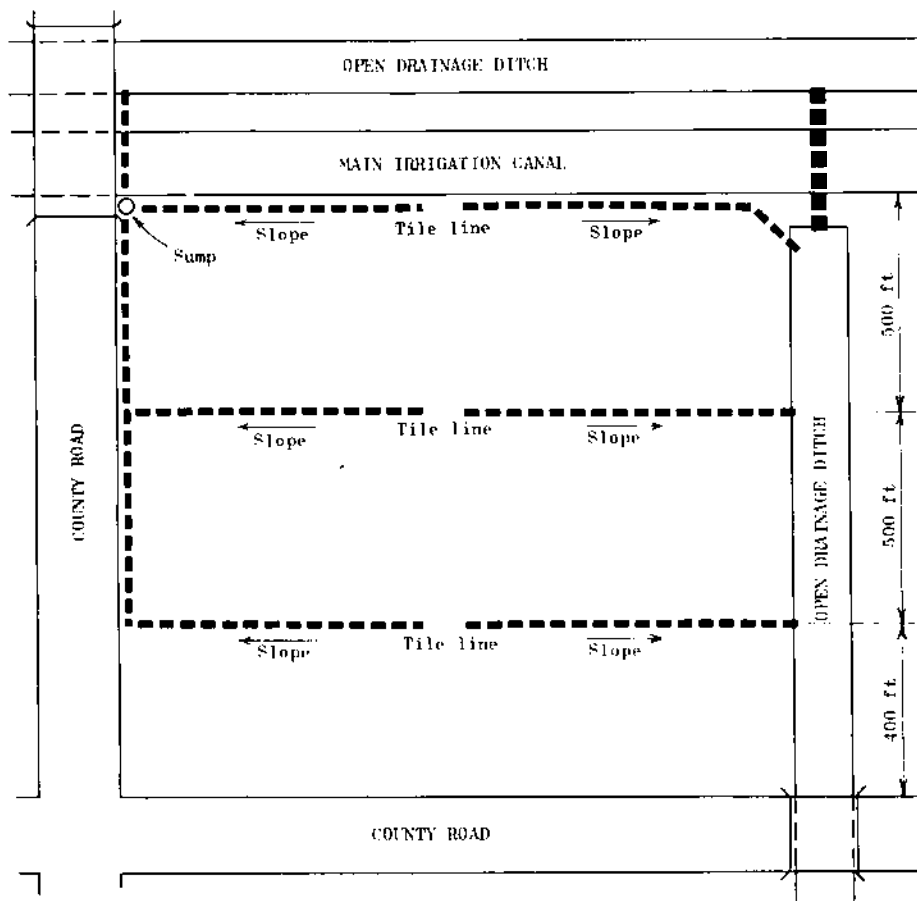
TYPICAL FIELD LAYOUT IN TULELAKE BASIN WITH OPEN AND TILE DRAINS

80 acres, three lines are installed at 400- to 500-ft intervals on the organic type soils and 500 to 600 ft on the mineral soils. Six- and 8-inch main lines are used, and 4-inch lateral lines are connected to the main lines to correct special drainage problems. Tile size is increased toward the outlet by at least 2 inches of diameter for each 1,300 ft.

portance of locating the tile lines to allow sufficient depth and avoid interference by farm operations. Three lines are usually located lengthwise through the field in a typical installation. The approximate center of the field is the shallowest portion of the tile installation and the lines are graded at a 0.1% slope each direction from this point. There is usually an open drain on the bottom or top of the field and another open drain on one side. The tile lines drain directly into the open drains on one or both ends of the field. On the side, three lines are brought into one large line which runs into a sump or drains into the open drain running adjacent to the field. All individual lines drain in two directions to remove water more rapidly from fields (see diagram).
