# Progress in MECHANIZATION OF WINE GRAPES S. S. JOHNSON · R. T. ROGERS ... economic factors

T HE USDA'S ECONOMIC RESEARCH Service and the University of California, Davis, are cooperating in an economic analysis of the mechanical harvesting of wine grapes. Machine harvesting of grapes in California began in 1969 and expanded to over 100 machines

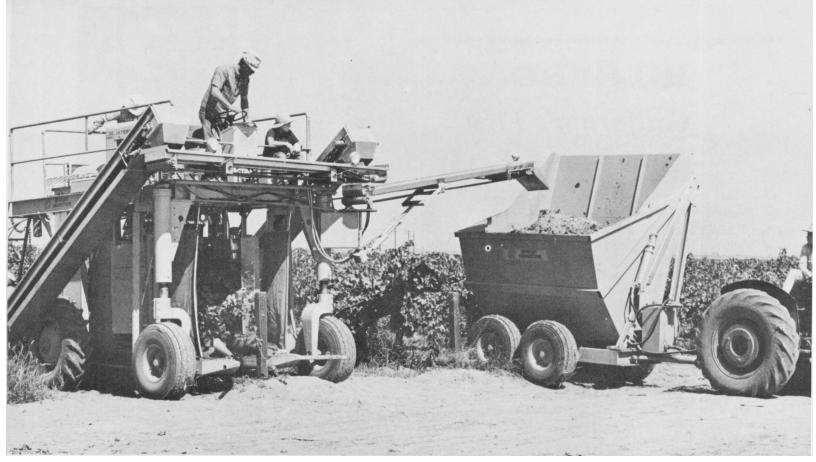
Wine grape harvesting equipment includes the grape harvester, a 5-ton self-dumping gondola, and a 40 to 60 hp tractor.

In mechanical harvesting of grapes, the harvester uses a beating action to shake the grapes loose. Straddling the row, the machine head beats the vine with a set of beater rods. The fruit falls to a catching tray, and from there is conveyed to the top of the machine, and is blown into a tractor-pulled gondola moving alongside. The closure device at the bottom of the harvester is flexible enough to permit moving around the trunk of the vines and the stakes (for more technical information, see your local farm advisor for *Mechanical Harvesting of Grapes for the Winery*, University of California AXT-403, 1973).

The average crew consists of the harvester operator, two tractor drivers, and one other person who helps keep the operation running smoothly. Some growers have one or two people to help strip vines or to remove, from the conveyors, trash which could plug up the fans. Two 5-ton self-dumping gondolas are commonly used with each harvester, alternating in use so that while one is loading the other is dumping. Since these gondolas are much heavier than the 1- to 2-ton gondolas used for hand crews, tractors in the 40 to 60 hp range are required which are capable of very slow speeds. Where the smaller gondolas are used, a forklift or similar dumping device is needed.

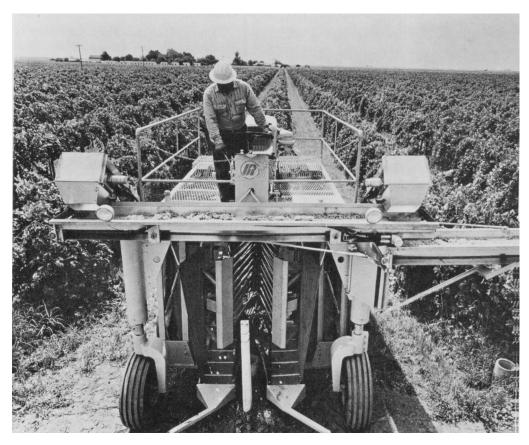
The harvester operator is the key to an efficient operation. He must be able to harvest the grapes with a minimum of damage to the vines, stakes, and obstructions.

The most important member of the crew is the machine operator. It is his

responsibility to avoid damaging vines, wires, and stakes, and to allow for proper clearance of any obstacles—while obtaining the maximum quantity of trash-free fruit. The operator needs to be mechanically inclined and responsible. Many growers consider the operator the key to successful mechanical harvesting.
